Science and Education Administration  
In Cooperation With  
Food Safety and Quality Service  
UNITED STATES DEPARTMENT OF AGRICULTURE

Issued July 1978

## METHODS AND FACILITIES FOR GRADING BROILERS AND TURKEYS

1/  
By Clarence E. Harris

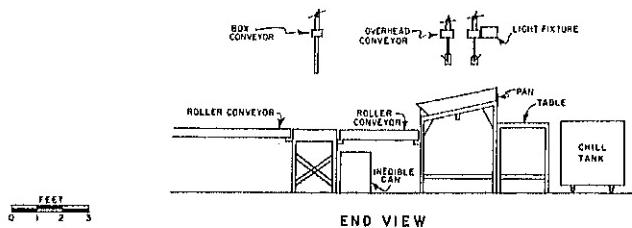
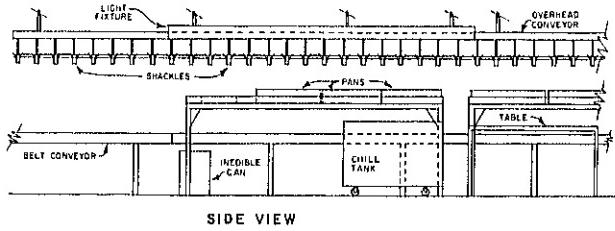
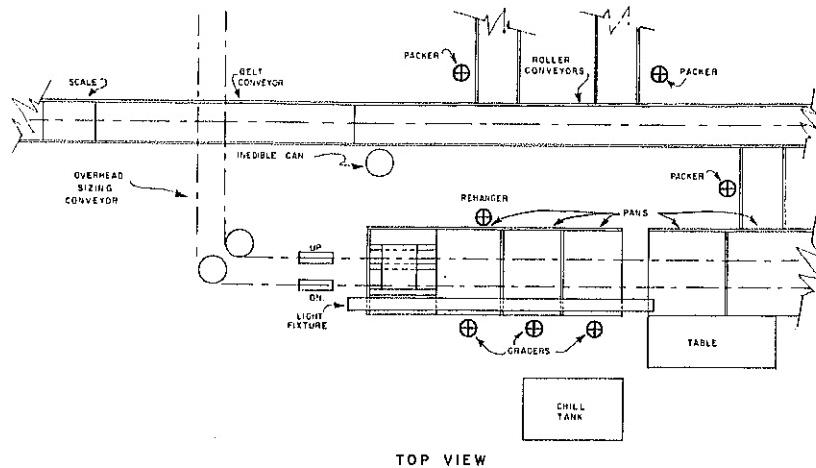
Figure 1.--Layout of broiler grading area in plant A.

Grading is primarily an in-line system in plant A. Figure 1 shows the layout of the grading area and arrangement of the equipment. The birds are suspended from nonrotating sizing shackles by one hock and are transported by shackles passing the grading station per minute. As the birds pass before the graders, they are graded according to U.S. grade standards. The grade A product is allowed to remain on the conveyor, and undergrades are removed and placed in designated pans. Each shackle has an identification, such as a color code or tag, so that each of the three graders can select every third movement to the top of the shackle, since this can detract from the grading function.

The desirable features of this grading area are as follows:

- (1) Space is adequate around the graders.
  - (2) Birds are presented at such a height that the graders can easily see the entire carcass.
  - (3) The layout necessitates only limited separation of undergrade birds. Once the graders have decided that a bird is an undergrade, they do not have to select from several choices in disposing of it.

- (4) Each grader is required to grade approximately the same number of birds because of the identified shackles and the uniform pacing by the overhead conveyor.

- (5) Adequate adjacent space and facilities are provided for reconditioning birds to meet grading requirements.
  - (6) Lights extend the full length of the grading area.

- (7) The hook of the shackle is turned toward the graders and thus does not obscure their vision of hock bruises and discolorations.
  - (8) The sloped pans keep the undergrade birds away from the graders.

- The undesirable features of this grading area are as follows:
- (1) The top of the pans restricts the graders' accessibility to the birds; they have to reach over the pans to get the birds.

- (2) The light fixture is too far in front of the graders so that the light shines in their eyes.
  - (3) The shorter employees require foot stands.

In plant A, the top of the pans for undergrade birds is 48-1/2 inches and the overhead conveyor shackles are 60 inches above the floor at the grading stations and at the opposite side of the pans where the undergrade birds are rehung on the overhead conveyor (cut-up line).

At the grading stations, the top of pans restricts the graders' accessibility to turn the birds around and to lift the undergrades from shackles since the top is 48-1/2 inches high. However, the shorter graders normally use a foot stand, which is usually 8 inches or less in height for safety reasons. Thus, when the short person is raised to a working height of 45 inches, the top of the pans is 3-1/2 inches too high. The pan height is more convenient for men, but even for them the pans are too high.

To alleviate the height problem for the short graders and to make the birds more accessible to others, the overhead conveyor could be raised 6 to 10 inches and a platform with a guardrail around it could be installed in the grading area. This platform should be wide and sturdy to insure safety and it could have adjustable legs so it could be raised or lowered to satisfy the graders' needs. Raising the overhead conveyor by 6 to 10 inches would bring the breast of the birds, suspended from the shackles, to the approximate eye level of graders. For women this is 58 inches from the floor (4).

Since the light fixture is too close horizontally to the overhead conveyor so that it shines into the eyes of the graders, it should be moved away from the overhead conveyor and raised to 6 feet 8 inches above the floor.

Another way to improve the grading operation is to provide more space between graders. In plant A, the pans for undergraduate products are 30-1/2 inches apart and tend to limit the workspace for each grader to that width. With the shackles 6 inches on center and the overhead conveyor traveling at 100 shackles per minute past a given point, the grader has only 3 seconds per bird to perform his task when confined to 2-1/2 feet, whereas when the grader has 3 feet of space, he will have 3-3/5 seconds. Therefore, at least 3 feet of space should be provided for each grader. This can be accomplished by moving the table for wing tags and separating the three pans for undergraduate birds to 6 inches or more or by using wider pans.

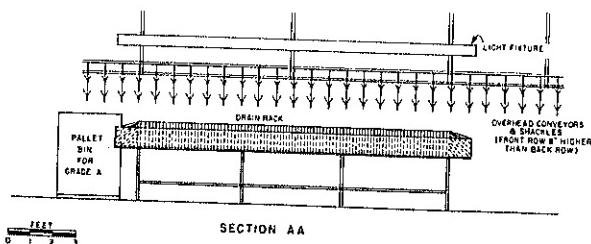
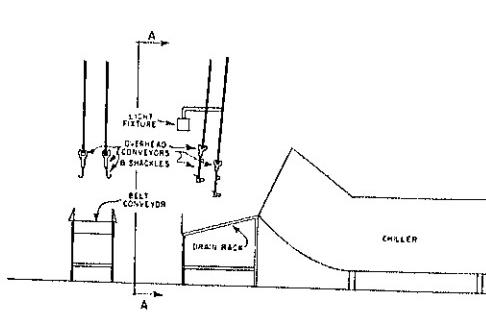
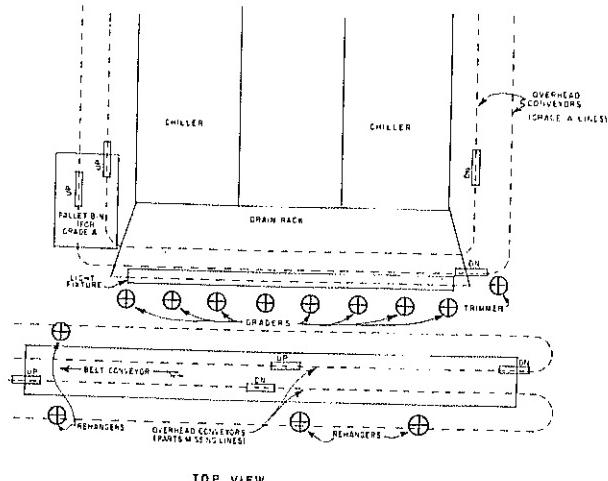
Figure 2.--Layout of broiler sorting area in plant B.

Figure 2 shows the layout of the sorting area, located at the exit end of the chilling machines, and figure 3 the layout of the grading area, located at a point just prior to the giblet stuffing operation.

In plant B, the birds are sorted as part of the function of transferring them from the chillers to the overhead conveyor (fig. 4). Those birds determined to be undergrades at the chiller drain rack are tossed onto a belt conveyor (fig. 5) located 3 feet from the drain rack and then hung on the overhead conveyor (cut-up line). The chiller drain rack area, where the birds are sorted, is well lighted by overhead fluorescent lamps covered with shields.

- (1) The grader has difficulty seeing the back of the birds, because they are suspended from the overhead conveyor by nonrotating shackles.
- (2) Undergrade birds are not easy to remove from the shackles.
- (3) One of the grading positions has inadequate space for grading and not enough room adjacent to it for reconditioning the product.
- (4) Each grading position is only 24 inches wide.
- (5) Since the floor is not well drained at the grading area, the graders stand on platforms, where their eye level is at about the height of the shackle rather than the bird.
- (6) The grading area is not well lighted.
- (7) Birds accumulate to an excessive depth in the drain rack at the sorting area and contribute to the inefficiency of sorting and hanging the birds and increasing the probability of some of them being left in the rack for extensive periods.

(8) The drain rack is approximately 17-1/2 feet long, with less than 2 feet of workspace for each of the eight graders and one trimmer.

(9) The overhead conveyor passes in front of all nine workers at a higher elevation as it goes out and at a lower elevation when it returns, traveling at approximately 250 shackles per minute. Once a grade A bird has been selected, the sorter often has to wait for an empty shackle, especially sorters near the middle of the drain rack. Trying to hang a bird on a fast-moving conveyor line is awkward and inefficient.

The sorting area is too congested. One way to alleviate this problem is to provide more drain rack space or frontage. This could be accomplished by moving the chillers farther apart and adding more rack in that area; however, moving the chillers probably would be costly, both in moving expense and wasted floorspace between the chillers. Another way to get more rack space would be to extend the rack at either end using deflectors or belt conveyors to move the birds out the ends. Complete separation of the two hanging areas, with separate slower moving overhead conveyors, would probably facilitate the highest degree of efficiency; however, this alteration also would be costly. In many other plants the sorting and hanging are performed from a belt conveyor moving in the same direction as the overhead conveyor. Usually the birds slide onto the moving belt conveyor as they come out of the chiller, moving along the conveyor until they are on the overhead conveyor shackles or dropping into a chill tank at the end of the belt. This might be more efficient than the present system.

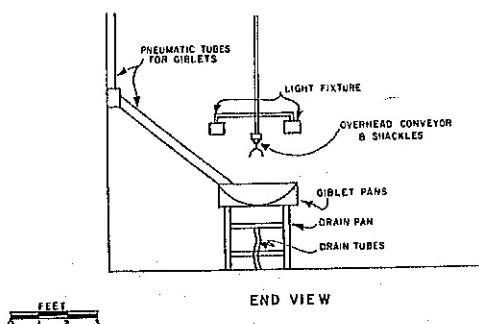
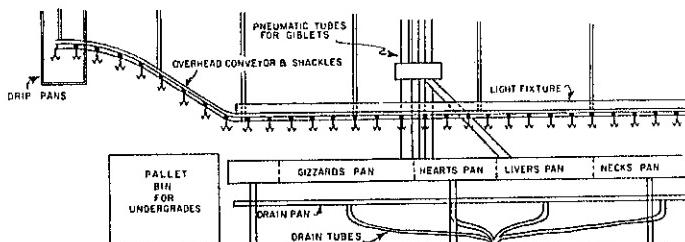
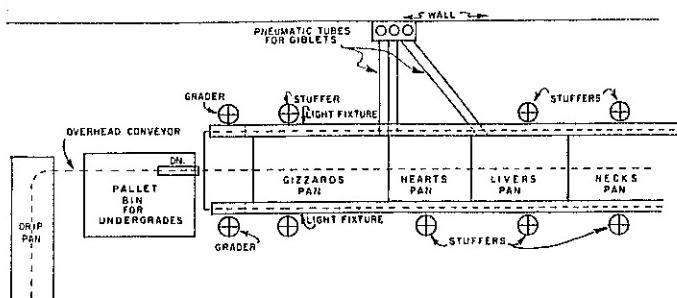
Figure 3.--Layout of broiler grading area in plant B.

Grading is performed on an overhead conveyor by two authorized graders (fig. 6). Undergrade birds removed from the conveyor at the point just before the giblet stuffing operation are dropped into a pallet bin, where, after accumulation, they are transported to another area of the plant and hung on an overhead conveyor for the cut-up operation.

The birds are suspended from shackles on the overhead conveyor by both hocks. Two shackles are welded to a bent stainless steel rod and attached to the overhead conveyor by a pendant. The birds are hung back to back with the breast side toward the graders. The shackles are 9 inches on center and the overhead conveyor (drip line) is approximately 200 feet long, with drip pans under about two-thirds of the line.

The grading operation in plant B could be improved by increasing the width of the grading stations and improving the floor drainage in the area or raising the height of the shackles at the grading stations. The taller graders have difficulty seeing the lower half of the birds, and if the floor were well drained, these graders could stand on the floor rather than on the platforms. Also, fluorescent or other approved lamps should be installed on each side of the grading line (fig. 3) at a height of 6 feet 8 inches and about 3 feet from the overhead conveyor, and they should provide at least 50 foot-candles of light (3).

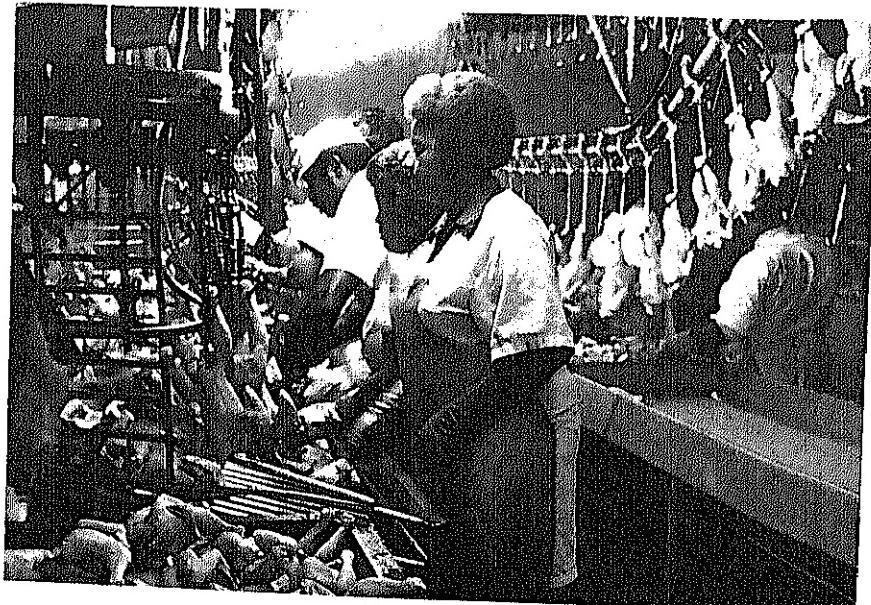
Figure 4.--Hanging birds at the drain rack.

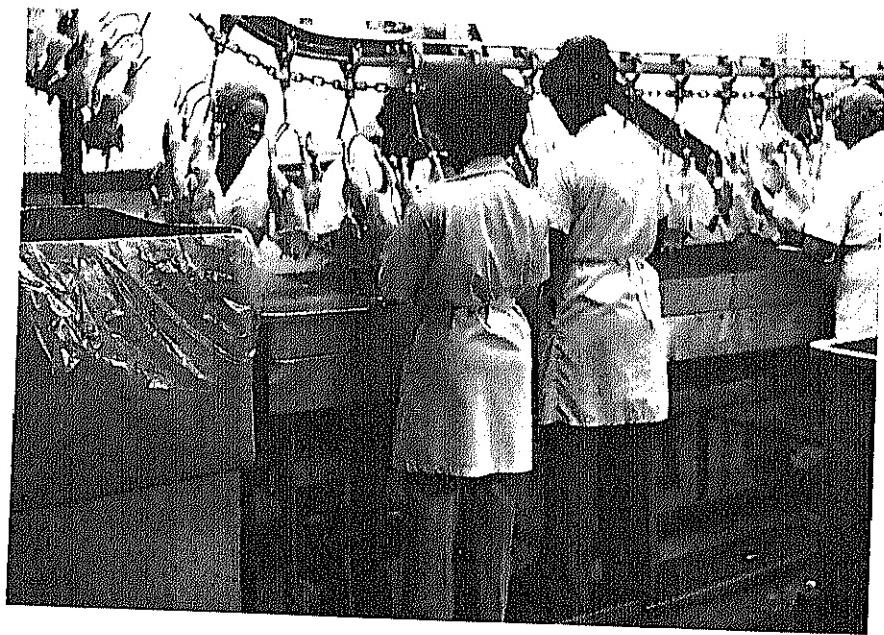
Figure 6.--Grading by authorized graders.

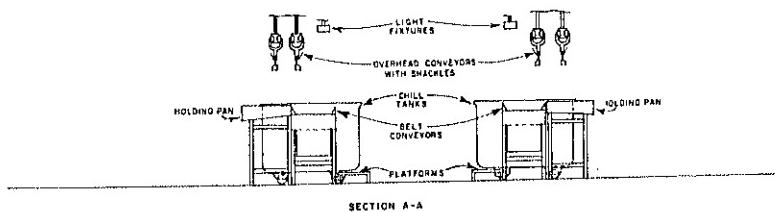
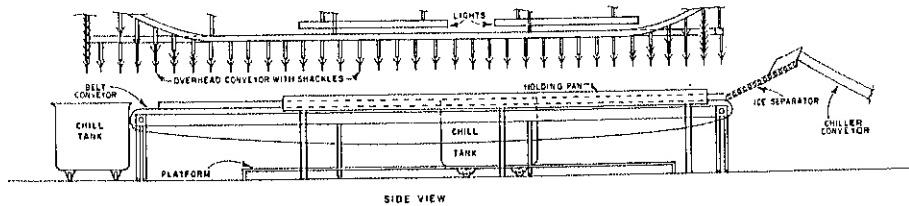
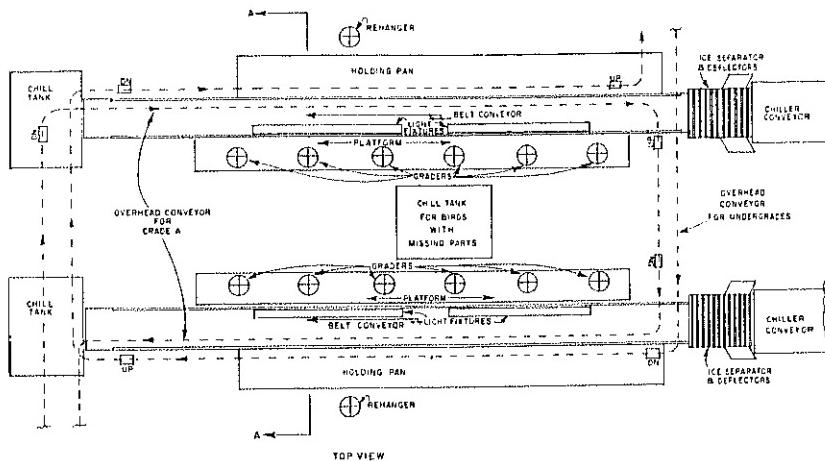
Figure 7.--Layout of broiler grading area in plant C.

As the birds pass along the two 25-foot belt conveyors (fig. 7), each one is lifted from the belt and graded. Those meeting the grade A standards are hung by a hook in shackles on an overhead conveyor, which takes them to the sizer located in another area of the plant. The undergraduate birds are tossed into stainless steel holding pans, 17 feet 8 inches long and 2 feet wide, alongside the belt conveyors. From the holding pans, the birds are rehung on shackles of the overhead conveyor for undergraduates. Both overhead conveyors serve as drip lines. Giblets are stuffed in the grade A birds before sizing.

The shackles on the grade A line are 18 inches above the belt conveyor and 9 inches on center. Likewise, the undergraduate line is 14 inches above the top of the holding pans and 9 inches on center. The grade A line is 14 inches from the front side of the belt conveyor and the undergraduate line is 16 inches from the outside edge of the holding pan.

Platforms 5 inches high, 16 inches wide, and 18 feet long are along each of the grading belt conveyors for the graders. The conveyor is 3 feet above the floor.

(1) Because the birds are mingled together on the belt conveyors, the production rates of the first two or three graders on the line are restricted since they have to separate the birds before grading them.

(2) Likewise, some of the graders near the end of the belt conveyors have to wait for empty shackles to hang their grade A birds, because many of the shackles have been filled by other graders.

(3) The grading function is not equally distributed among the graders; the first graders have to grade more birds than those at the opposite end of the grading belts.

(4) The grading operation occupies an excessive amount of floorspace relative to grading operations in other plants.

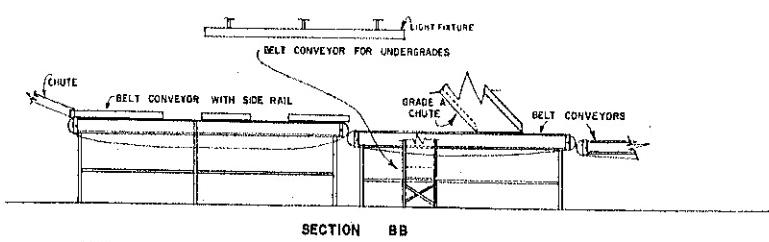
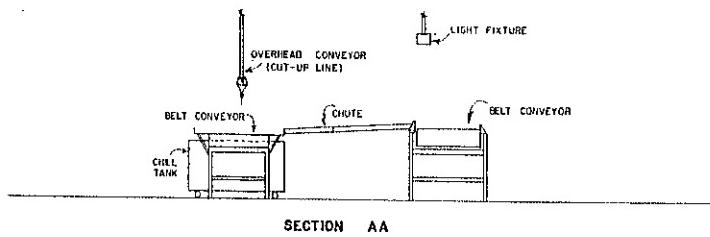
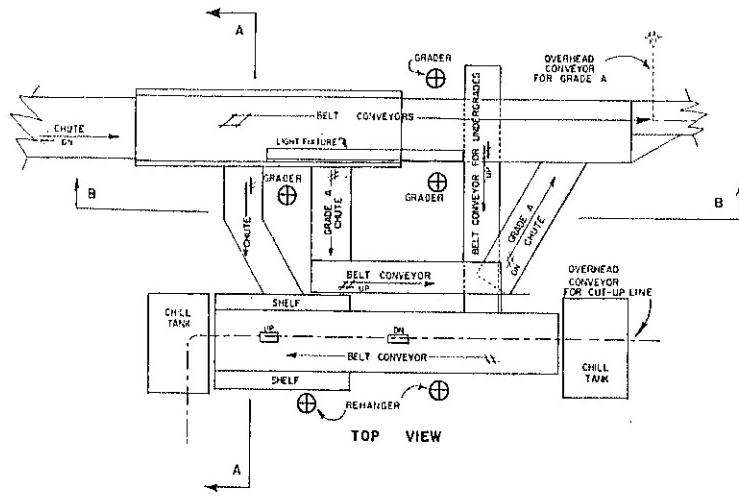
Figure 8.--Layout of turkey grading area in plant D.

The chutes are stainless steel with 3-inch-high sides formed by bending the steel. The chutes on both sides of the first grader are 36 inches above the floor, where they are attached to the grading belt conveyor.

The 28-inch-wide undergrade belt conveyor has a smooth surface. Shelves, 8 inches wide with 3-inch-high sides, are on both sides of this conveyor. Chill tanks are situated at each end of the undergrade conveyor, and above its center is an overhead conveyor. Shackle clearance above the belt is 10-1/2 inches; the shackles are 12 inches on center. The overhead and belt conveyors travel in the same direction.

(1) The grading area has inadequate space for maneuvering from front to back of the workplace, and accessibility is restrictive, particularly for two of the grading positions.

(5) Safety and noise levels at the grading area could be a problem. A belt conveyor operating about 5 to 6 feet above the floor and behind one of the graders could be a safety hazard. The grader has to go under a chute while stepping over another belt conveyor in order to get to and from the grading position. This is inconvenient and unsafe. Noise at the grading area is relatively high because numerous machines are operating close to the graders.

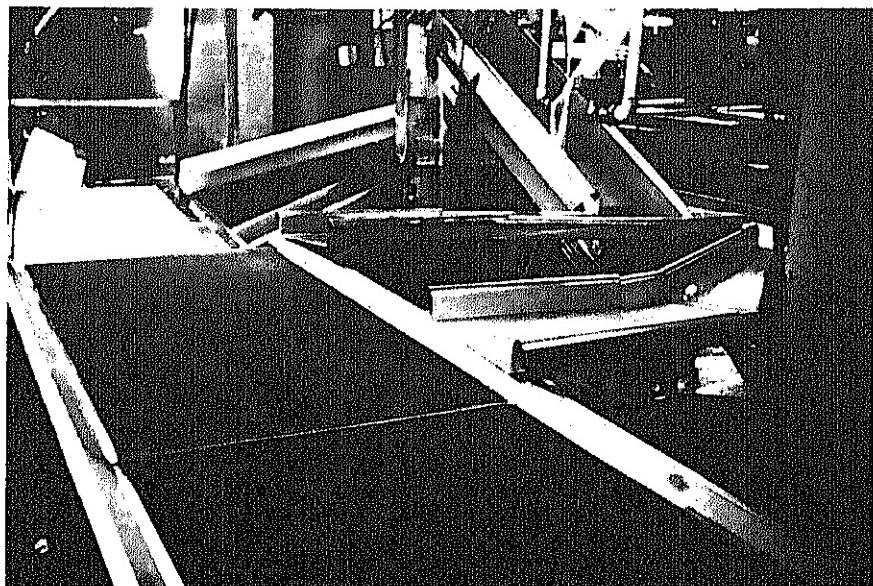
Figure 9.--Belt conveyor for grading birds as they pass from the chiller to the white belt (background).

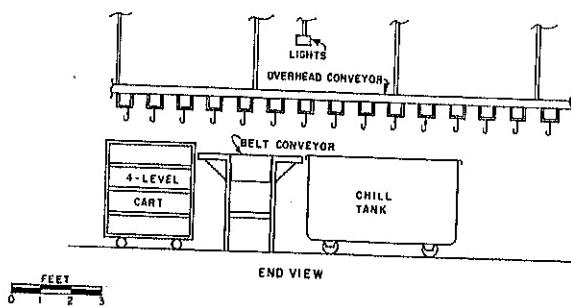
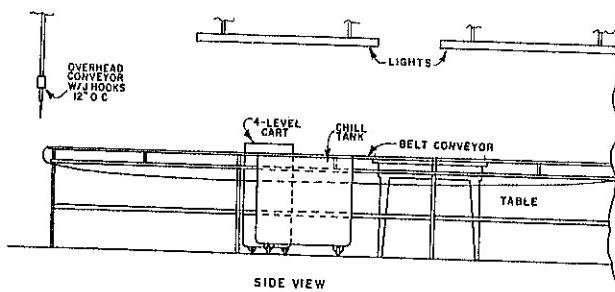
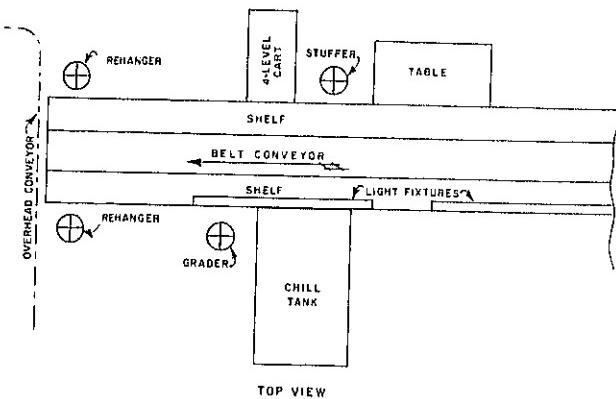
Figure 10.--Layout of turkey grading area in plant E,

The 16-inch-wide belt conveyor and the two 12-inch stainless steel shelves on either side provide space to separate the birds as they pass in front of the grader. The conveyor and shelves are 38 inches above the floor, which is 1 inch above the normal sitting-standing working height for women.

Light fixtures, 6 feet 8 inches above the floor, run parallel to the grading belt conveyor. They are directly above the outer edge of the stainless steel shelf, on the same side of the conveyor as the grader, and almost directly above the grader's head.

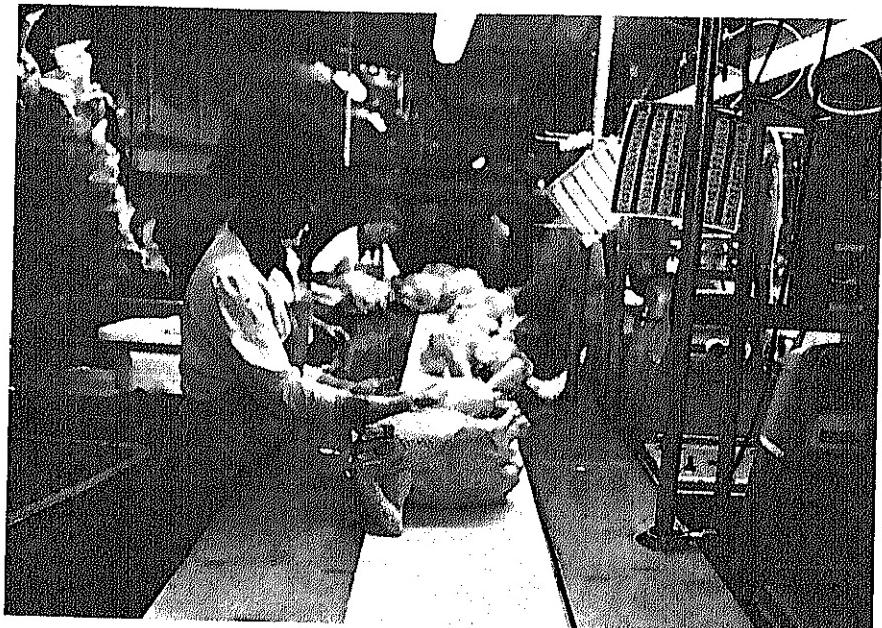
Figure 11.--Turkeys being moved along the belt conveyor to the grading area.

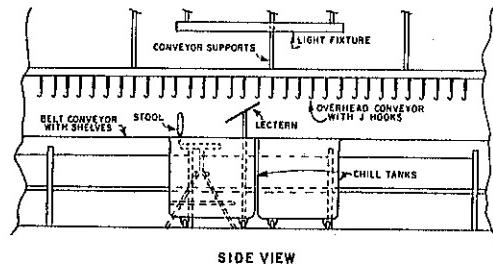
Figure 13.--Layout of turkey grading area in plant F.

The layout of the grading area is shown in figure 13. Plant F has "producer grading," with the grade data being recorded. This is available to all qualifying plants on request. As the birds are transported by the belt conveyor (fig. 14), the grader holds each one by a wing and observes the condition of the breast side. If the standards for grade A are met, the bird is turned on end and the back side is checked. Grade A birds are left on the belt, continuing to the next work station, where they are hung in shackles attached to the overhead conveyor. Giblets are stuffed in the birds after they leave the grading area. Undergrade birds are deposited in chill tanks (fig. 14) behind the grader. Space around the grading area is ample, as shown in figure 14, and the noise level, which is relatively low at approximately 80-85 decibels of the A scale, contributes to an effective work station.

The J hooks attached to the overhead conveyor above the grading belt are 6 inches on center, with a clearance of 22 inches between the bottom of the hooks and the conveyor belt. The top side of the belt conveyor is 33 inches above the floor, and the outer edges of the sloped stainless steel shelves are 37 inches above the floor.

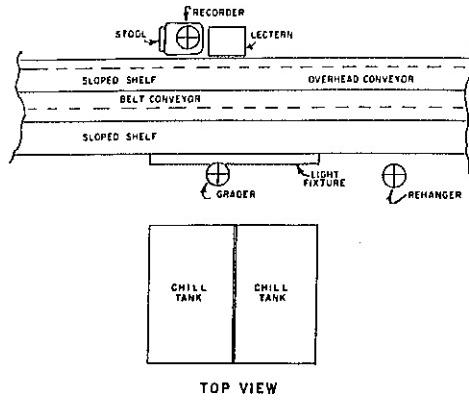
Figure 14.--Grading area with chill tanks for undergrade birds (foreground).

(2) J hooks moving past the grading area at 4 feet 8 inches above the floor could be hazardous because they are close to eye level.
